THAMES RIVER BASIN
ASHFORD, CONNECTICUT
GOSS BROOK DAM
CT 00465

PHASE I INSPECTION REPORT
NATIONAL DAM INSPECTION PROGRAM

SEPTEMBER, 1980

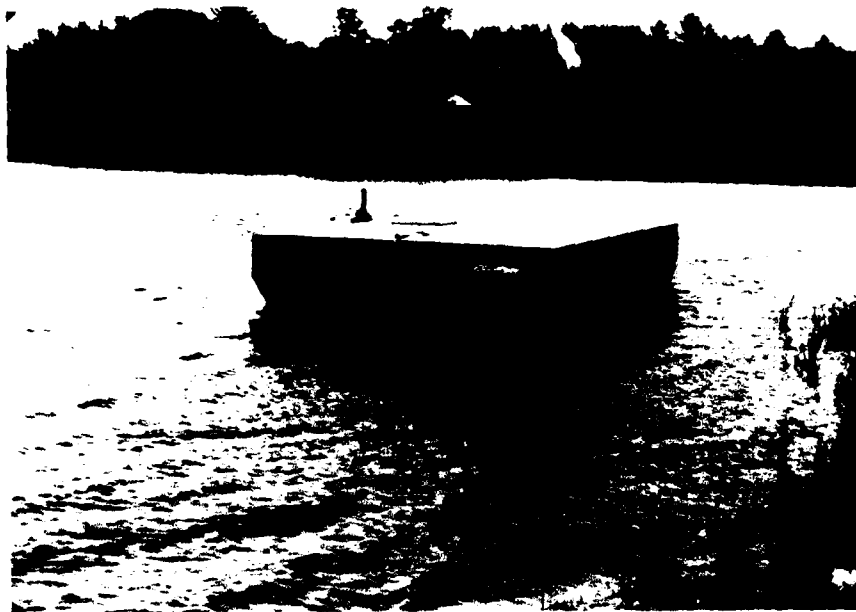
Spillways - There is no access bridge from the dam to the principal spillway structure, but viewed from the dam the concrete appears in very good condition with only very minor spalling noted below the normal pool elevation (Photo 5). It was observed that the uppermost pipe of the left side trash rack was mostly above the water surface, while that on the right side was mostly submerged. Subsequent lock level measurements also suggest that the top of the structure on the left side is about 3/4+ inch above the top on the right side, indicating possible tilting of the structure. The spillway crest and upstream face of the concrete riser could not be inspected. Observed from its downstream end, the 42 inch spillway discharge conduit appears to be in good condition (Photo 6).

Photo 5 - Principal spillway intake structure (8/21/80).

It is recommended that the owner retain the services of a registered professional engineer and licensed surveyor to monitor any possible movement of the principal spillway structure and to design riprap to prevent erosion of the emergency spillway embankment.

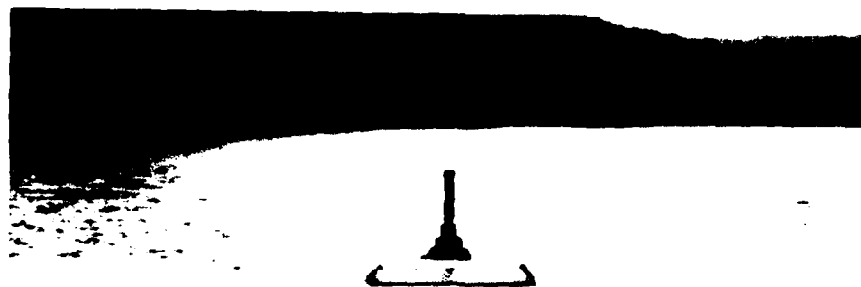
c. Appurtenant Structures - Due to lack of access from the dam, the low-level outlet gate mechanism could not be inspected. Viewed from the dam, there were not any noticeable defects or deficiencies in the gate valve stem and the operator reports that the gate is operable.

Photo 8 - Zoom - lens view of low-level outlet gate valve stem (8/21/80).
